CALSPAN ON-SITE AIR BAG DEPLOYMENT INVESTIGATION

CALSPAN CASE NO. 92-4

VEHICLE - 1986 FORD TEMPO GL

ACCIDENT DATE - ██████████ 1991

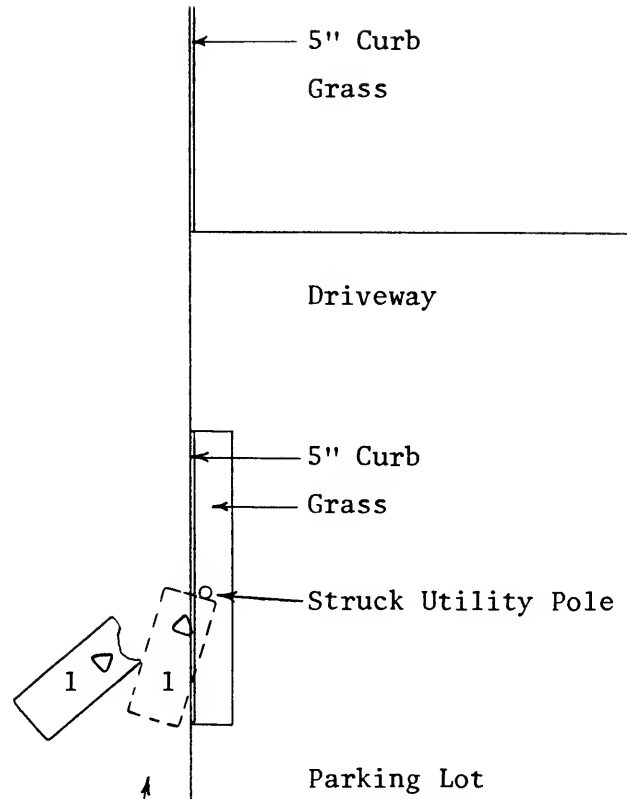
The crash occurred on a two lane city street in a posted 30 mph speed zone. The asphalt road surface was straight with a slight positive grade to the west. The vehicle was traveling in a westerly direction at an unknown, but reasonable rate of speed. The driver reportedly (police report) began to cough and lost control of the vehicle. She probably applied an unintentional clockwise steering input which caused the vehicle to drift to the right. The right front tire probably contacted a 5" barrier curb which deflected the front tires and rotated the steering wheel approximately 180° from the 12 o'clock position. It was unknown if the driver braked in an attempt to avoid the crash.

The right frontal area of the vehicle impacted a small diameter utility pole that was located 1' outboard of the curbline. Impact speed was computed at 14.0 mph by the damage and trajectory algorithm of the CRASHPC program. Direct contact damage began 5.6" right of center and extended 8" to the right on the front bumper face. Maximum crush was 14.75" and was located 13.1" right of center. The vehicle underwent a velocity change of 16.7 mph which was sufficient to deploy the vehicle's driver air bag system.

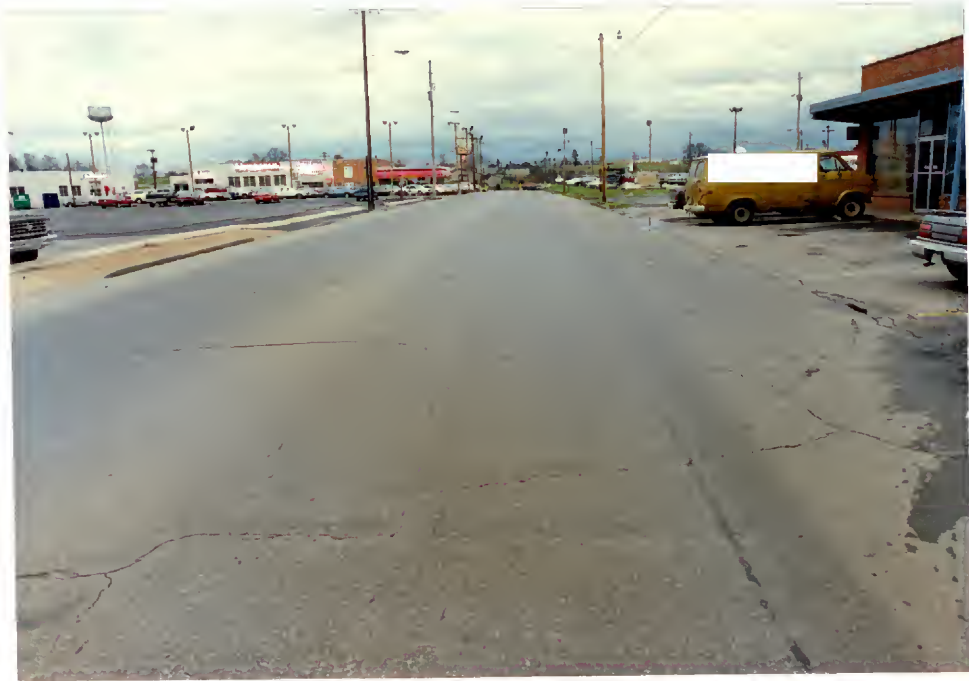
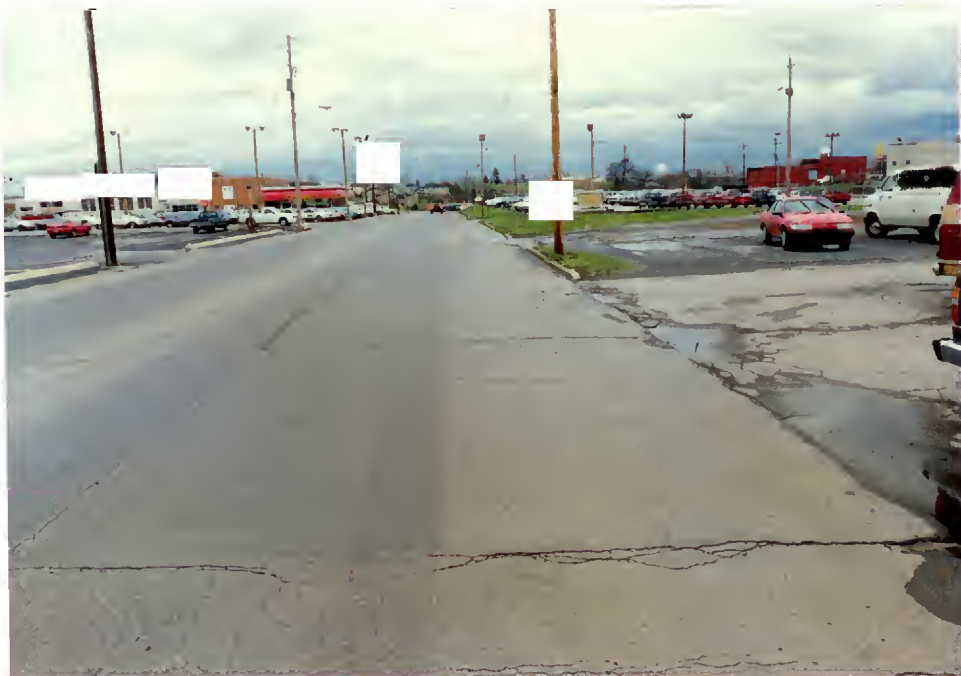
Pre-Crash Trajectory Of The 1986 Ford Tempo.

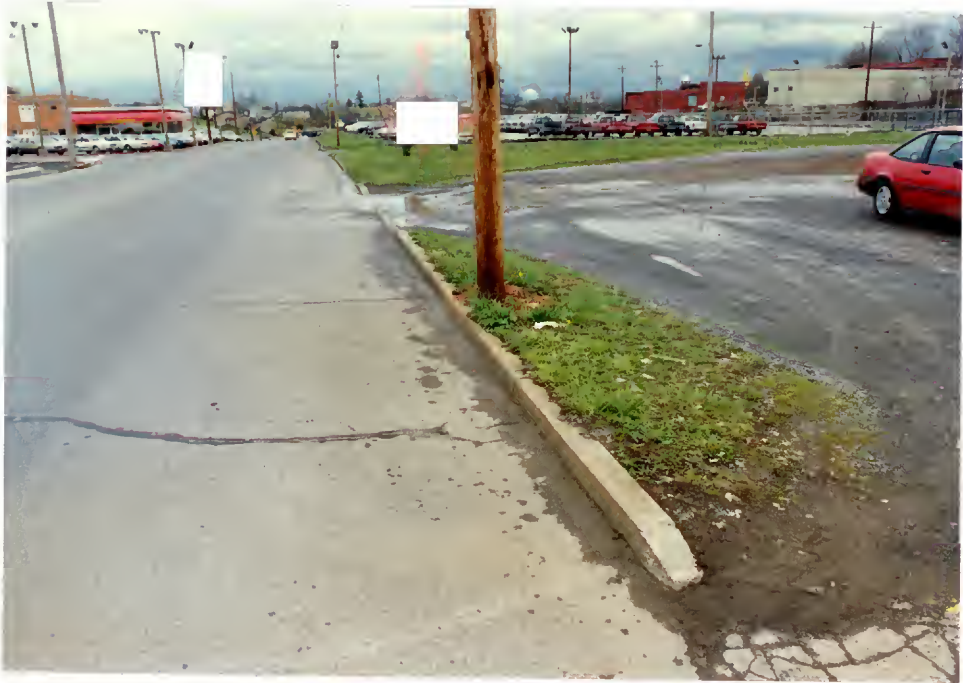
Struck Utility Pole.

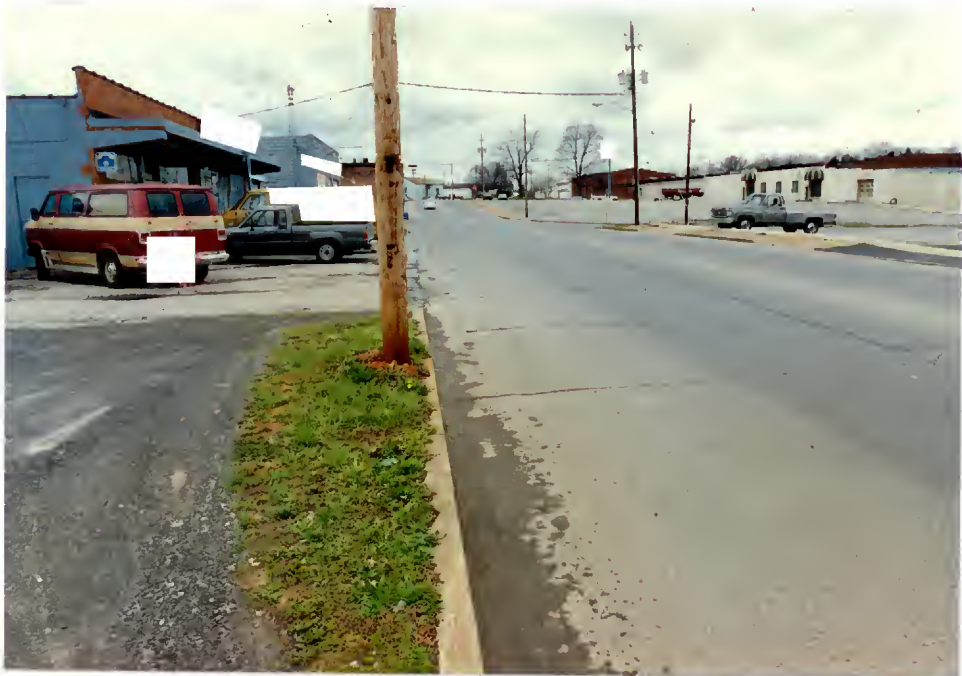
Lookback View Of The Vehicle's Trajectory.

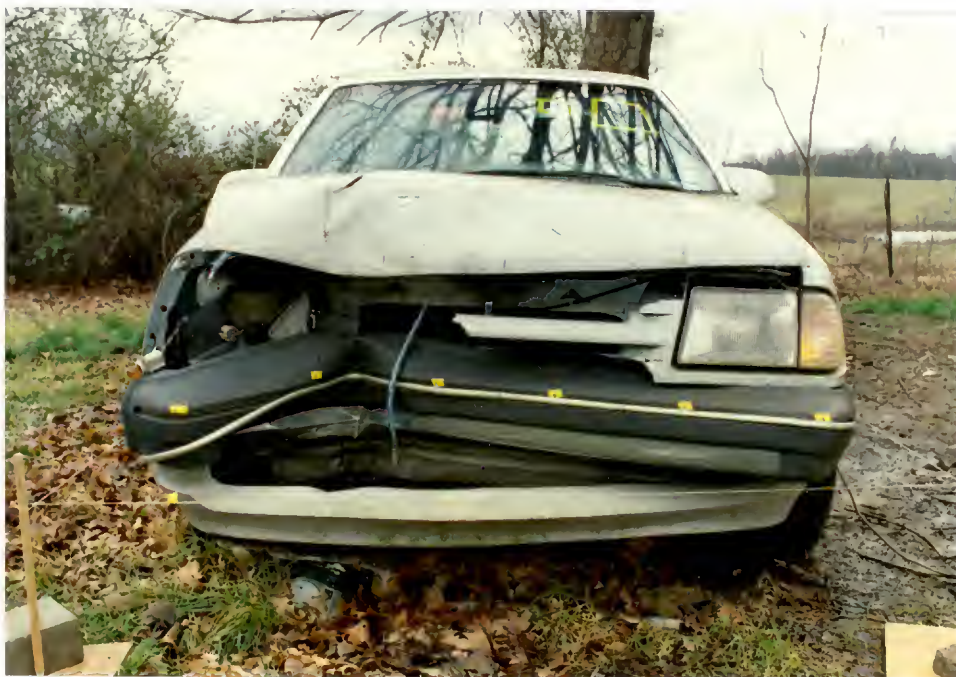
Frontal Damage To The Ford Tempo.

The Ford Tempo sustained moderate frontal damage as a result of its impact sequence with the wooden utility pole. Maximum crush was 14.75" located on the bumper face 13.1" right of center. Direct contact damage began 5.6" right of center and extended 8.0" to the right. The impact deformed the entire frontal width of the vehicle which resulted in a combined induced and direct contact damage length of 48". Crush values at bumper level were as follows: $C_1=0"$, $C_2=2.0"$, $C_3=6.0"$, $C_4=10.375"$, $C_5=12.0"$, $C_6=5.75"$.

Components damaged by the narrow frontal impact sequence included the front bumper, grille, right headlamp assembly, hood, radiator and radiator support panel, and the air conditioning condensor. The impact crushed the bumper to a V-configuration which displaced the front frame rails laterally inward. As a result of the rail displacement, the right front air bag crash sensor was rotated both inward and upward. The left crush sensor was rotated slightly clockwise.

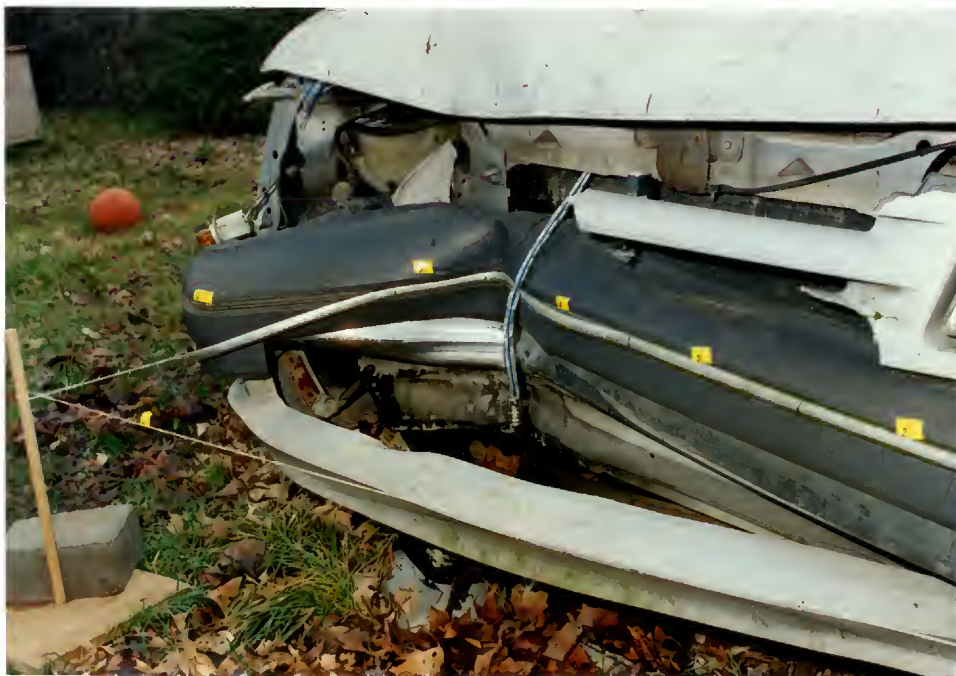
Closeup View Of The Pole Impact Damage.

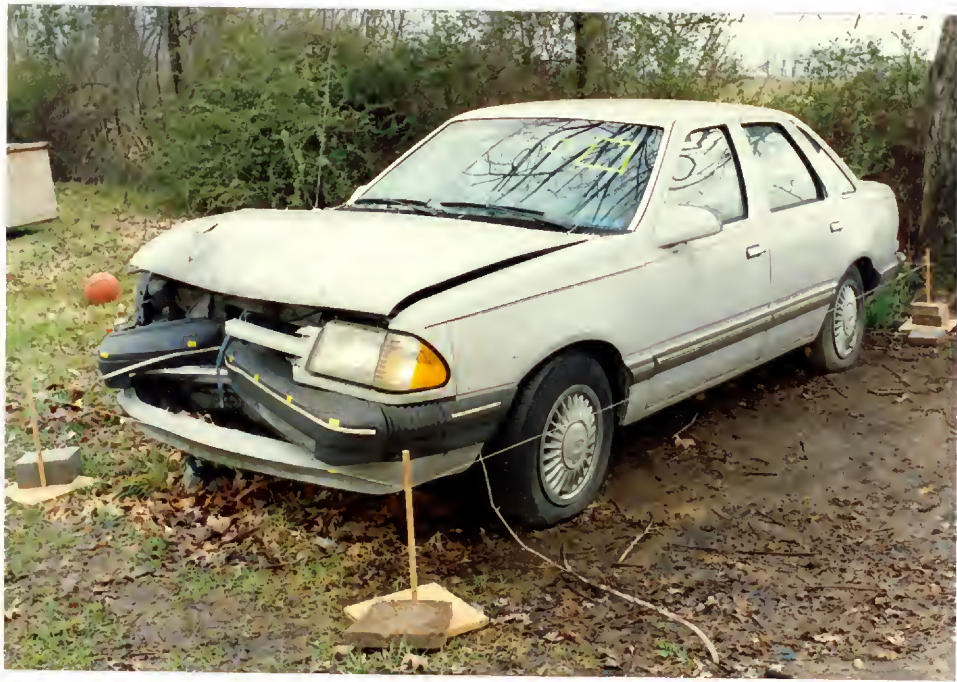
Left Front Three-Quarter View.

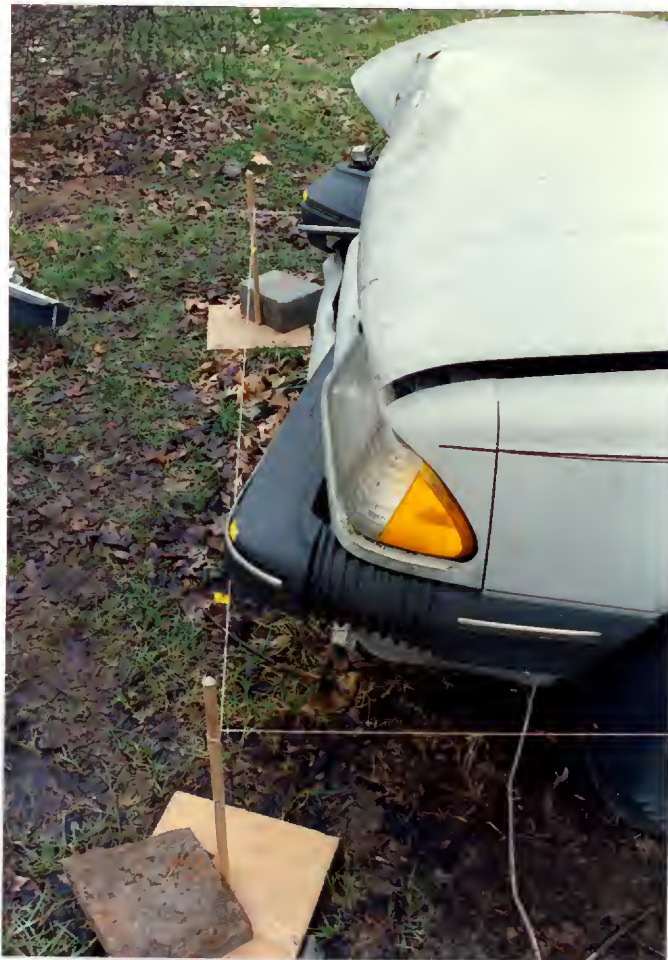
Left Perpendicular View Showing The Extent Of Crush.

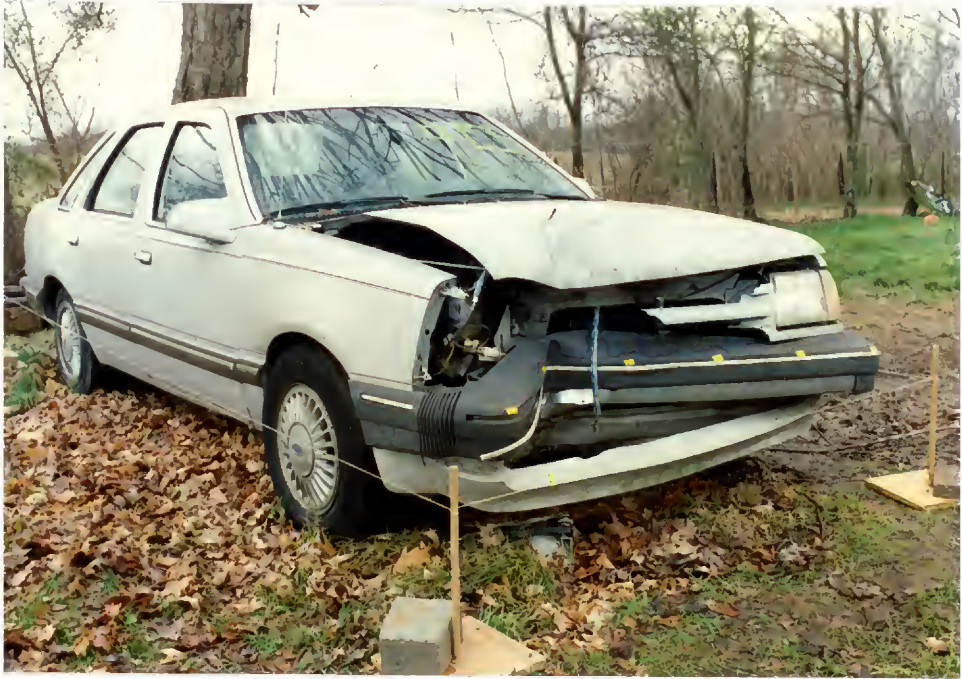
Right Front Three-Quarter View.

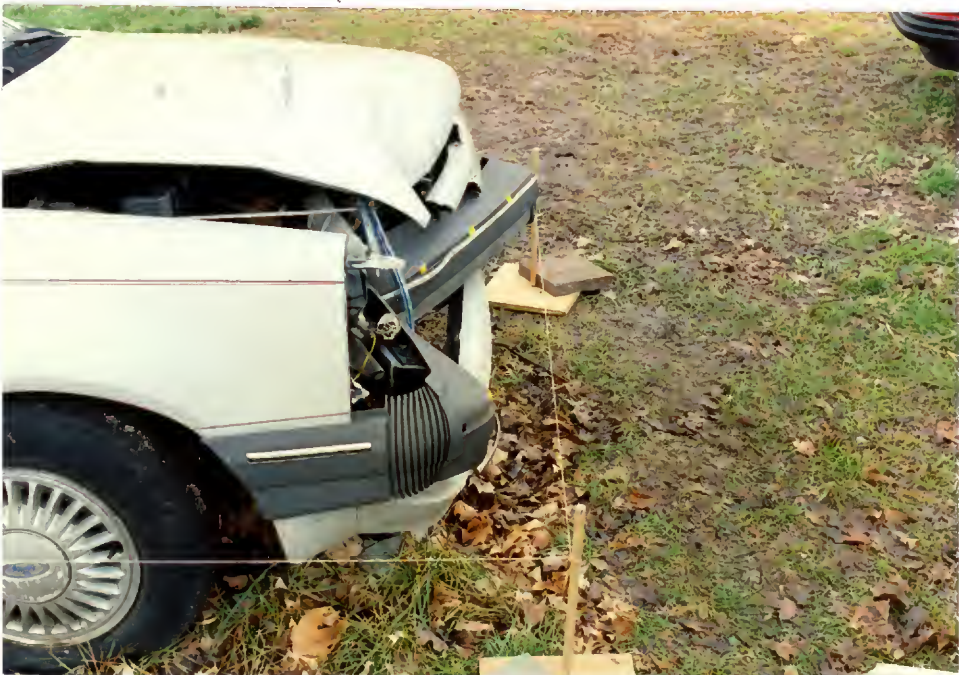
Right Perpendicular View Showing The Extent of Crush.

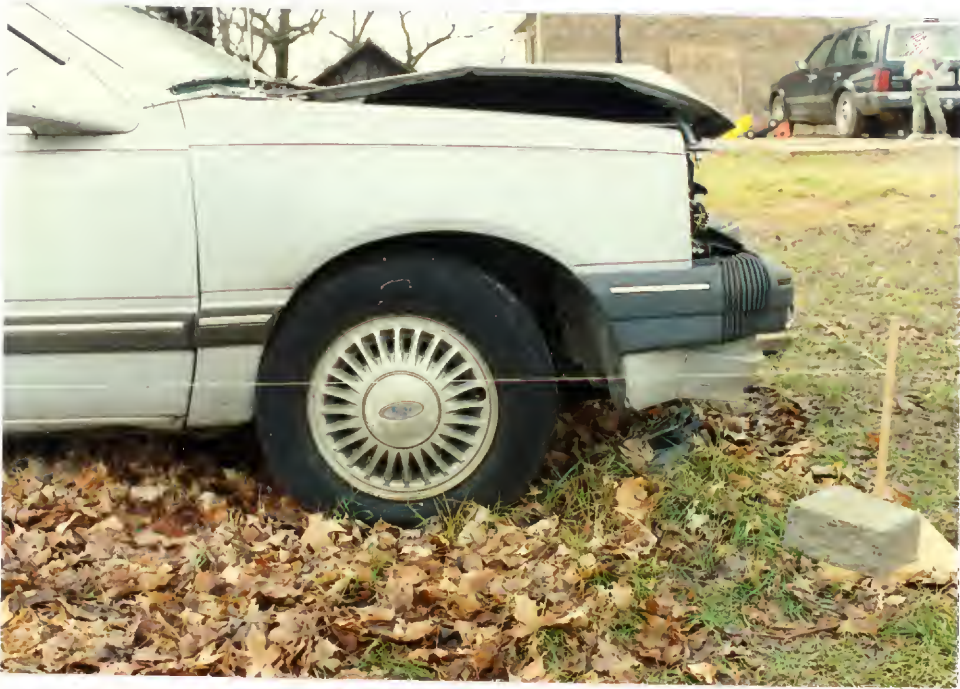
Rearward Displacement (3.1") Of The Right Front Axle Position.

The windshield was cracked as a result of impact induced stress and occupant contact. All doors remained closed and operational post-crash. The right wheelbase was reduced in size by 3.1"; however, the right front wheel was not locked by damage.

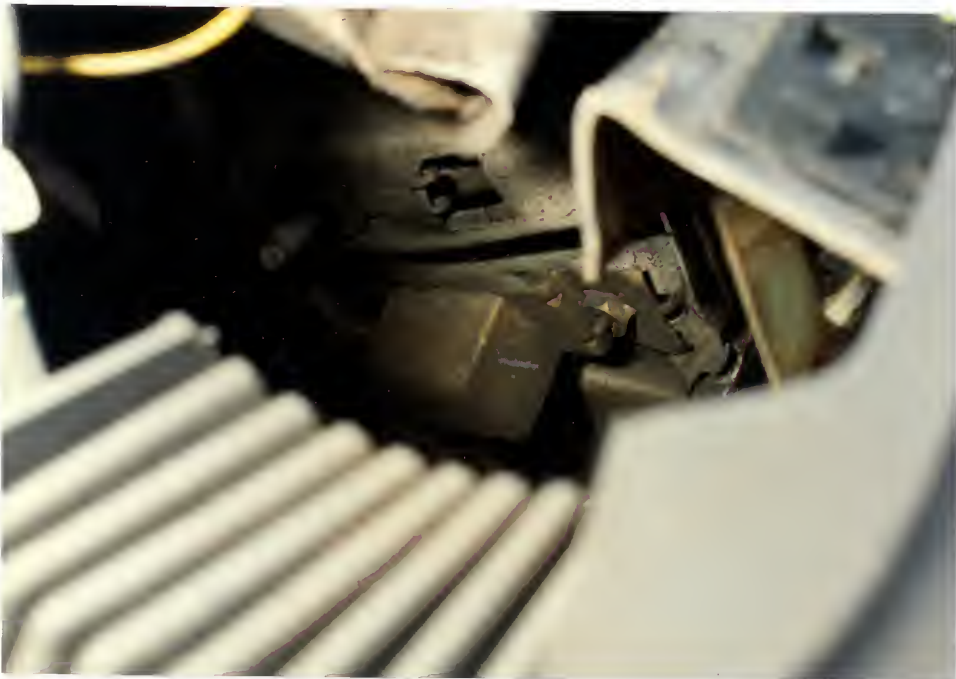
Front Right Air Bag Crash Sensor.

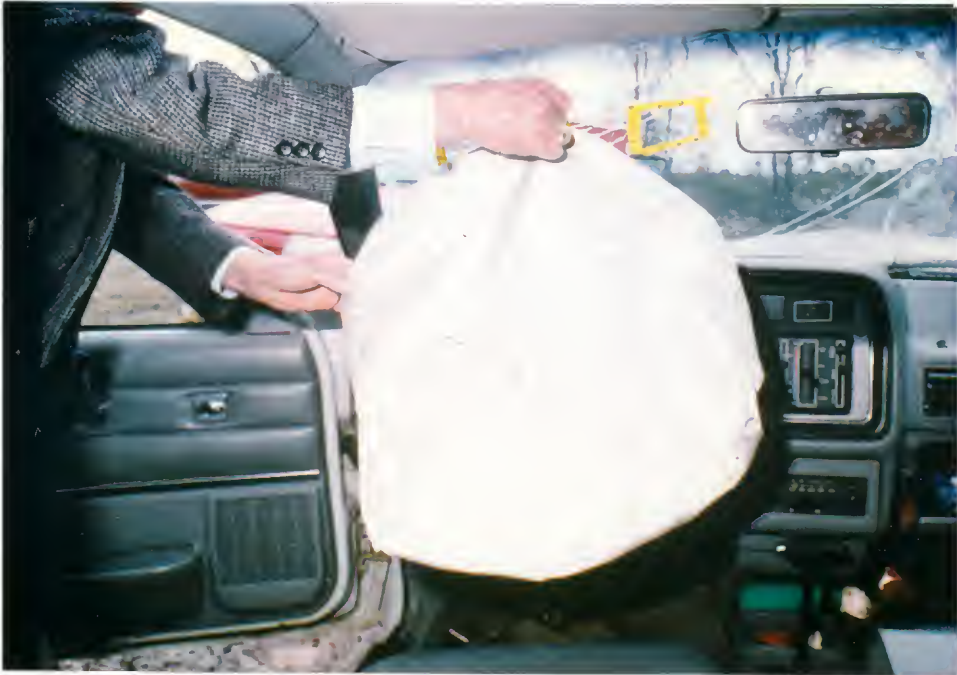
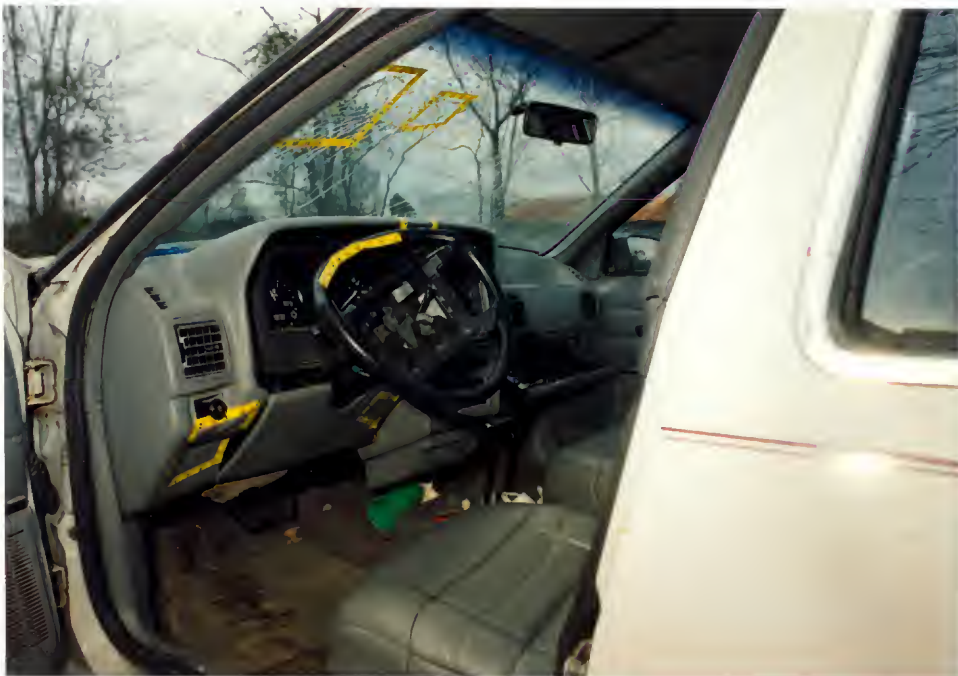
Overall Interior Views From The Left Door Area.

The interior of the Ford Tempo sustained moderate damage as a result of the crash forces and driver contact with interior components. The driver's left knee impacted the lower instrument panel immediately below the light switch. The contact produced a fabric patterned abrasion to the padded component 21.5-24.5" left of center and 11.5-15" below the upper instrument panel and deformed the panel to a depth of 1.25". Her right knee impacted the right side of the knee bolster and deposited a blue/black fabric transfer with an abrasion to the plastic panel. The contact, which was located 6.5-10.5" left of center and 13.75-14.875" below the upper panel, displaced the right side of the bolster 0.5" forward. The driver's abdominal area loaded the upper edge of the steering wheel rim as the wheel was rotated approximately 180° . Her loading force displaced the rim 3.25" forward and compressed the energy absorbing steering column 1.1" (shear capsule separation). The deformable bracket of the steering column had a residual displacement of 0.75". The driver's right hand probably separated from

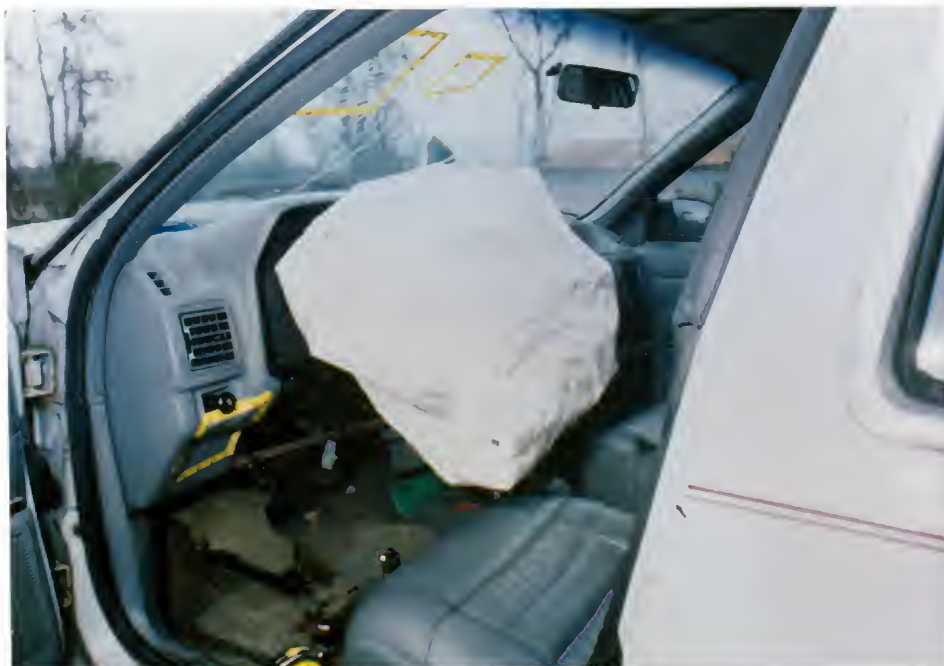
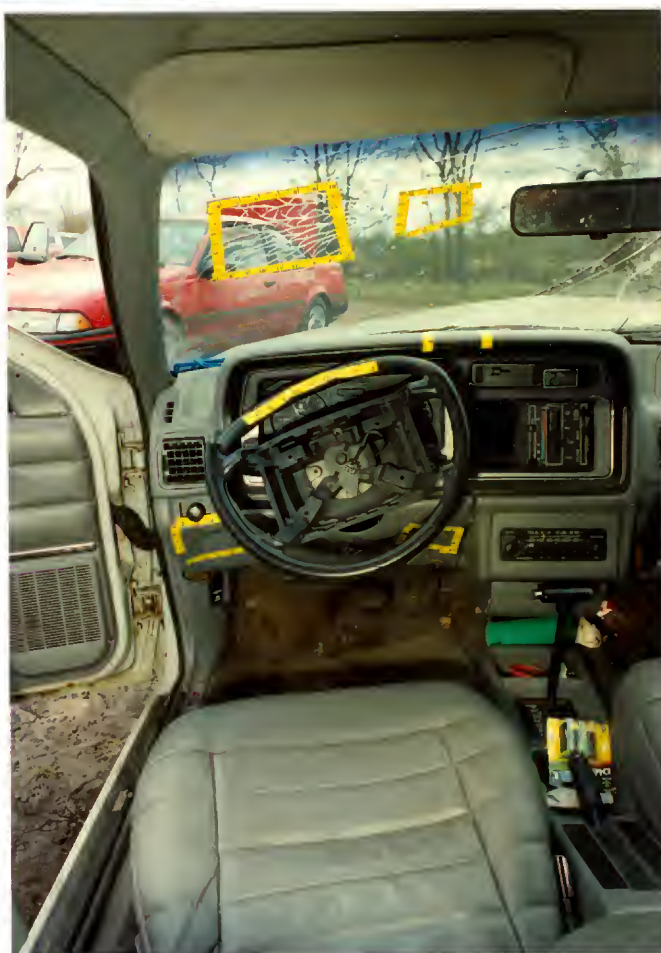
Driver's Trajectory And Interior Contact Points.

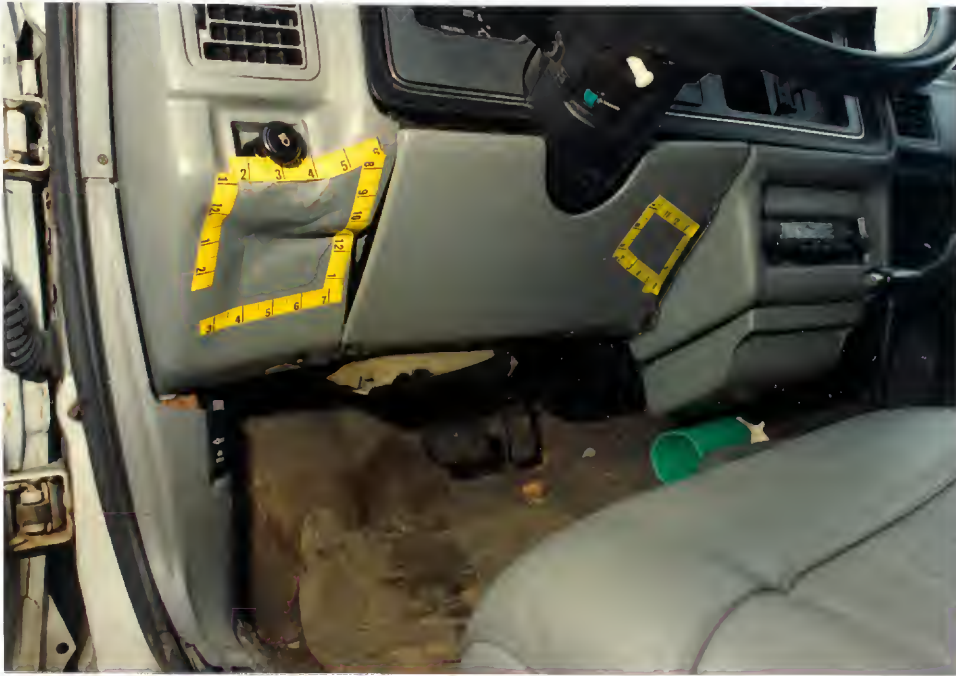
Driver Knee Contacts To The Lower Instrument Panel And Knee Bolster.

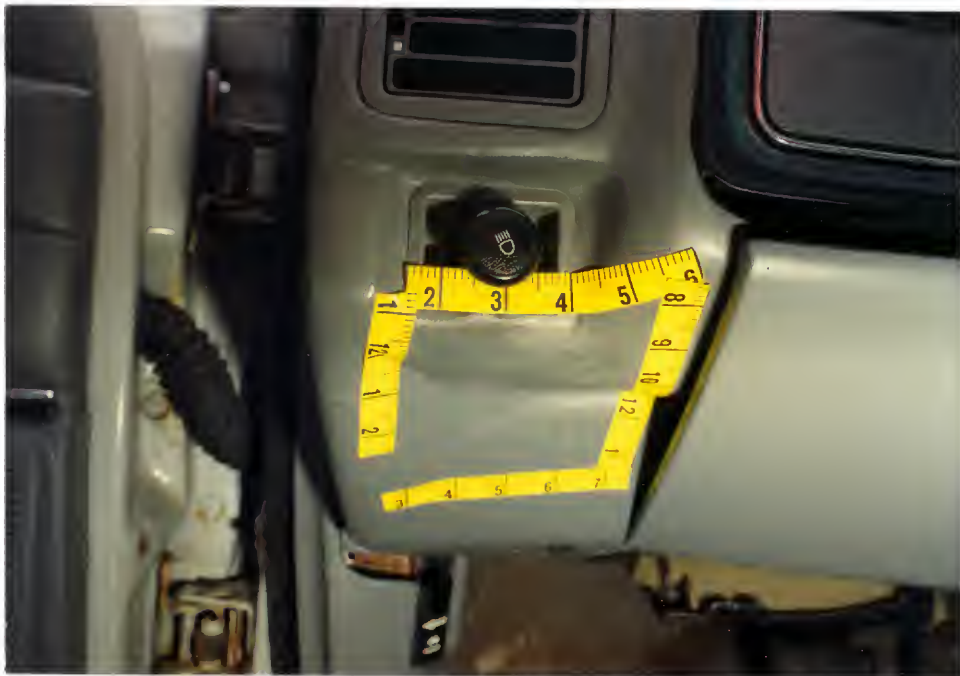
Left Knee Contact To The Lower Instrument Panel.

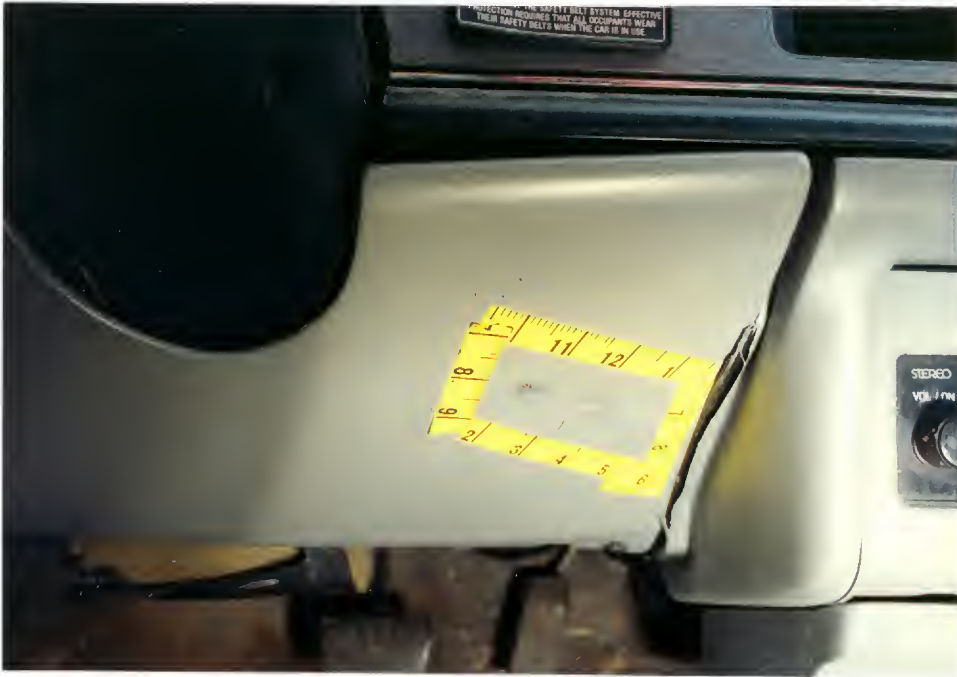
Right Knee Contact To The Knee Bolster.

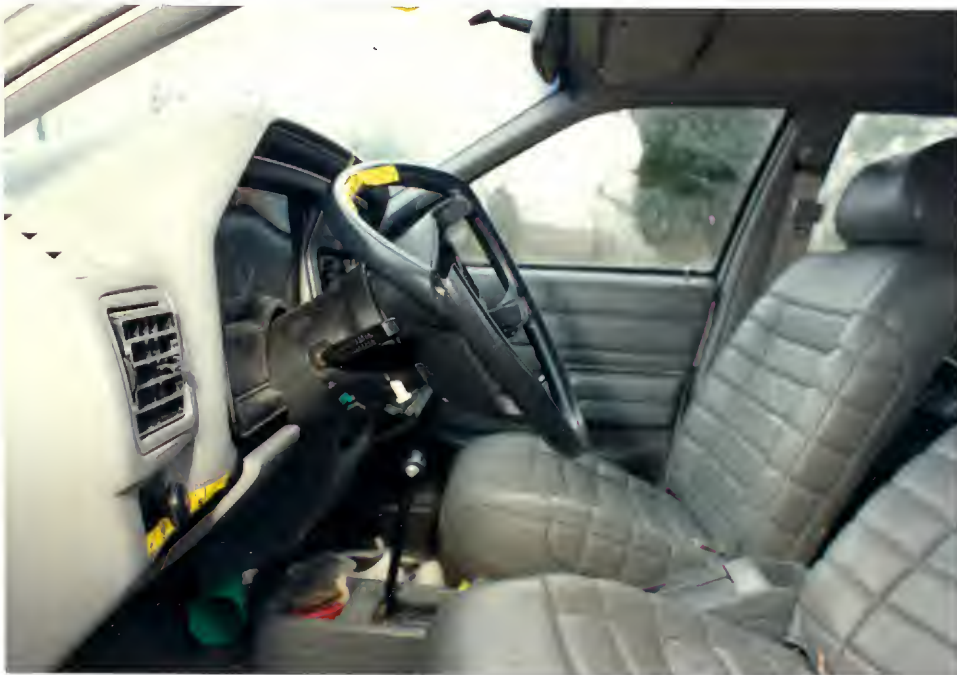
Driver's Abdominal Loading Of The Steering Wheel Rim
(Wheel Was Rotated 180° At Impact).

Due to the driver's forward position at impact, her upper abdominal area loaded the lower edge of the steering wheel rim (wheel was rotated 180° at impact) and deformed the rim 3.25" forward. Her contact with the soft edged steering wheel rim resulted in ecchymosis of the upper abdominal area and a ruptured spleen. Her torso contacted the deployed driver's air bag which resulted in bilateral breast contusions. As a result of her loading force against the steering wheel rim and the deployed air bag, the energy absorbing steering column compressed 1.1" (shear capsule compression).

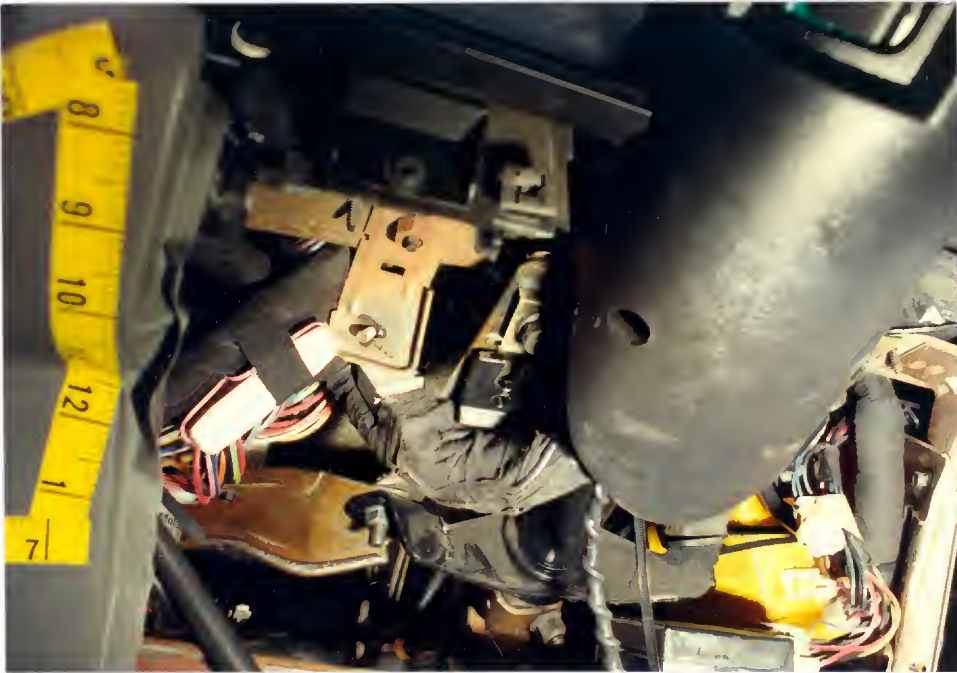
Left Shear Capsule Separation And Bending Of The Deformable Bracket.

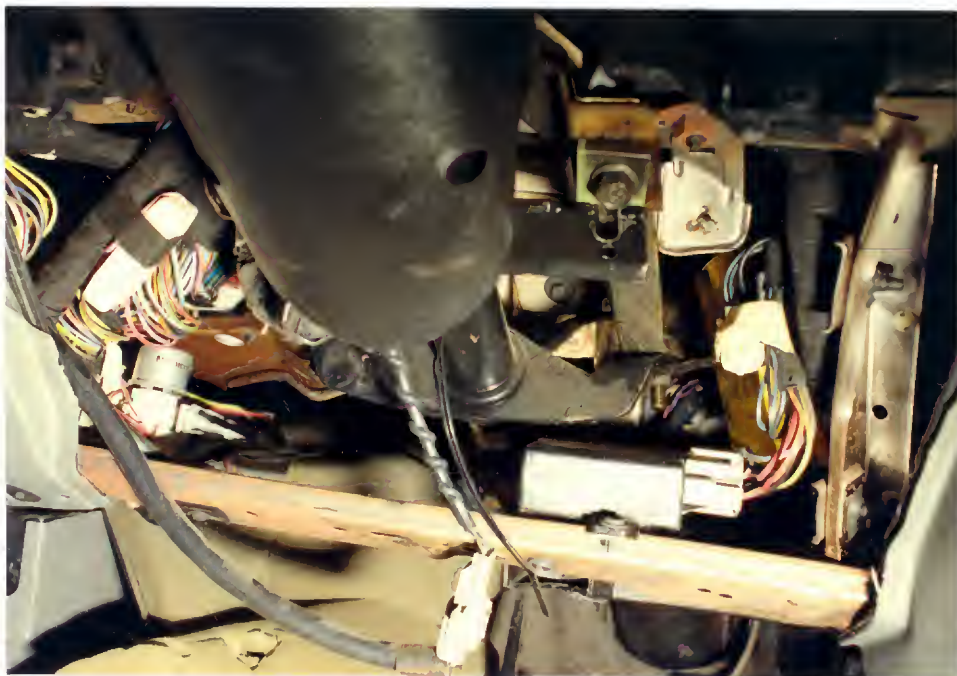
Right Shear Capsule Separation.

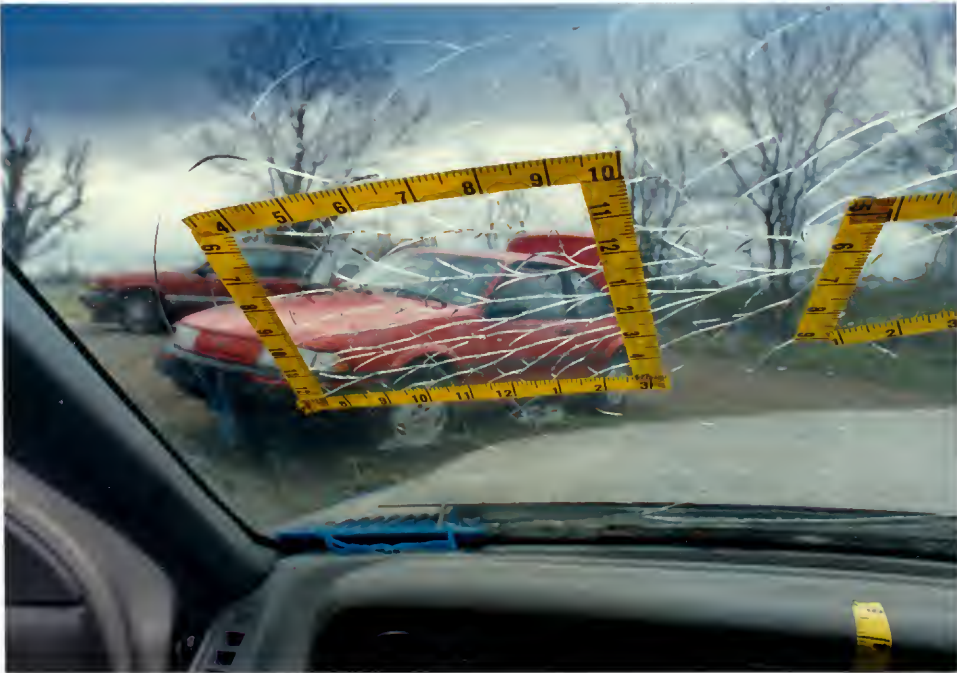
Probable Air Bag Contact To The Windshield.

The driver's forehead area pitched over the top of the air bag and impacted the windshield 6.5-9" left of center. The contact cracked the laminated glass and deposited tissue transfers on the glass 6.5-9" above the upper panel. No injury resulted from her contact with the windshield. Vertically oriented fabric transfers were noted to the windshield 13-19" left of center which resulted from air bag contact with the glass.

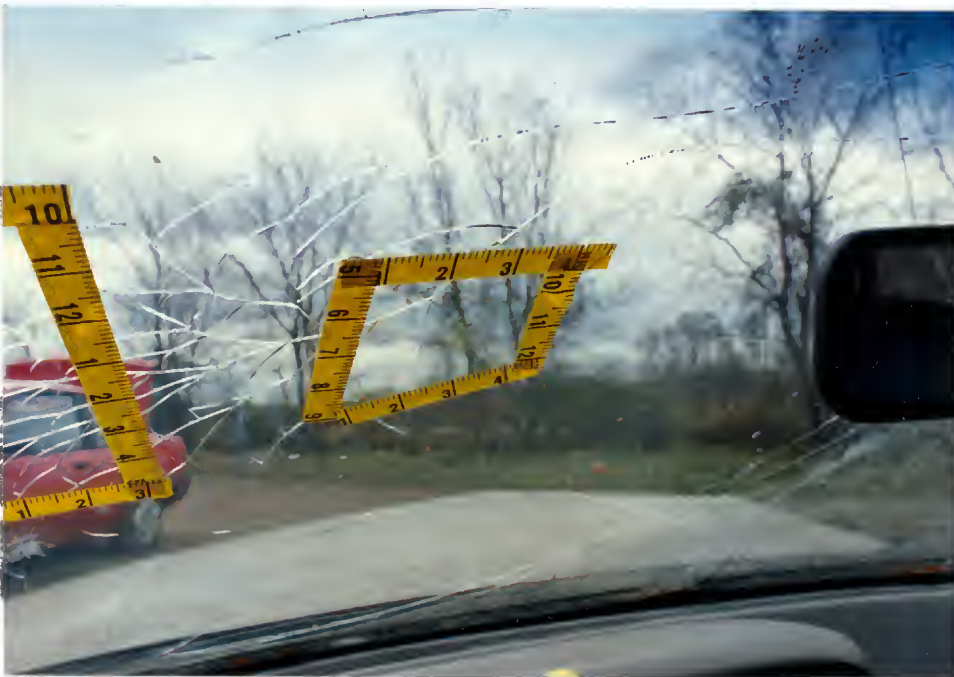
Driver Forehead Contact To The Windshield (Tissue Transfer).

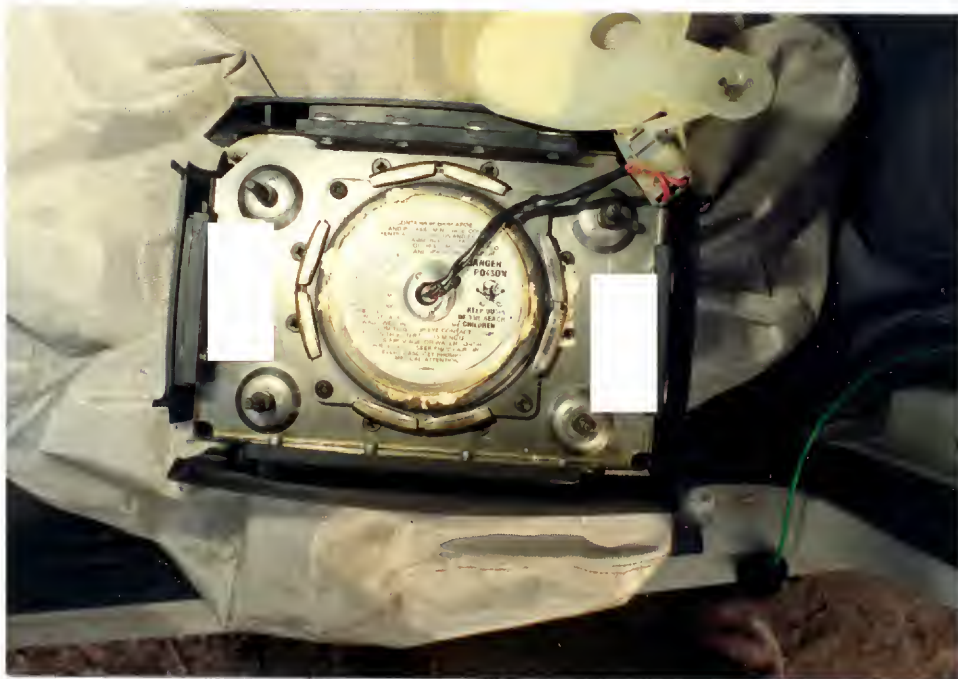
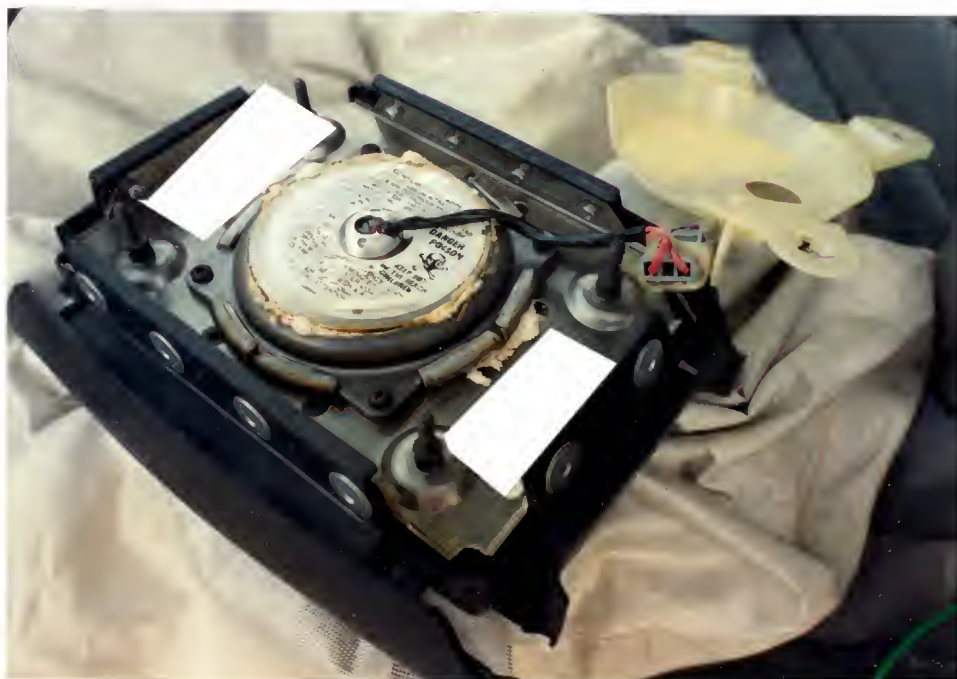
Backside Views Of The Air Bag Inflator Housing.

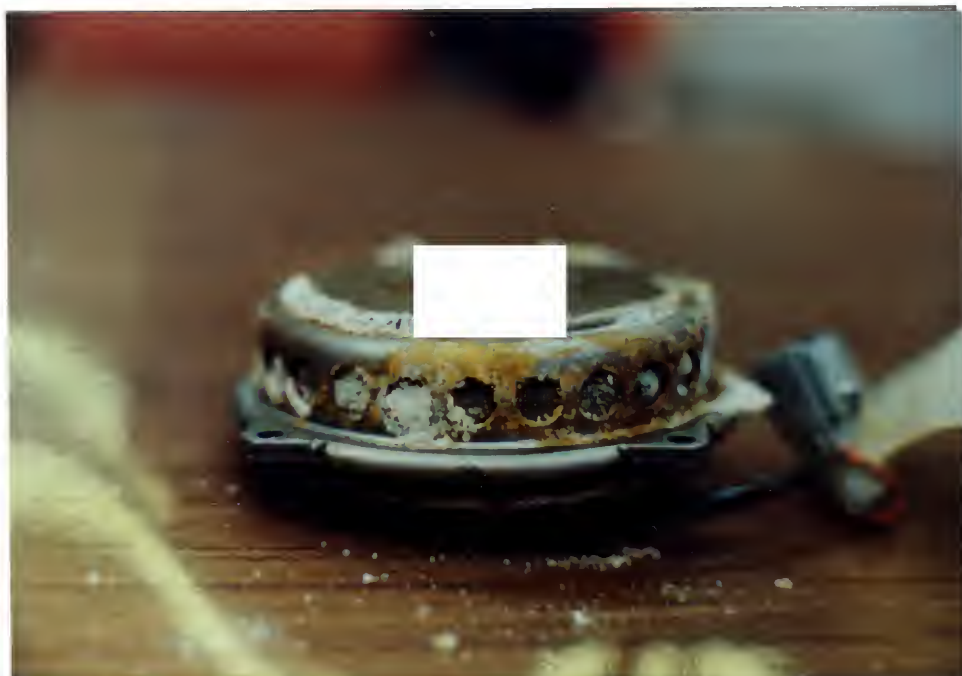
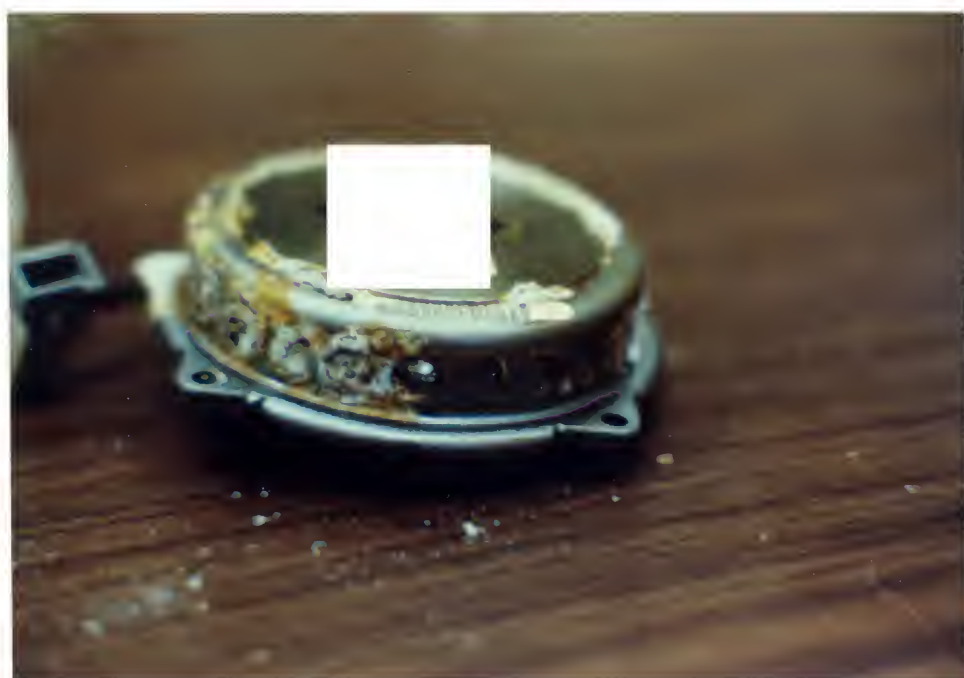
Generant Residue Deposits On The Inflator Ports.

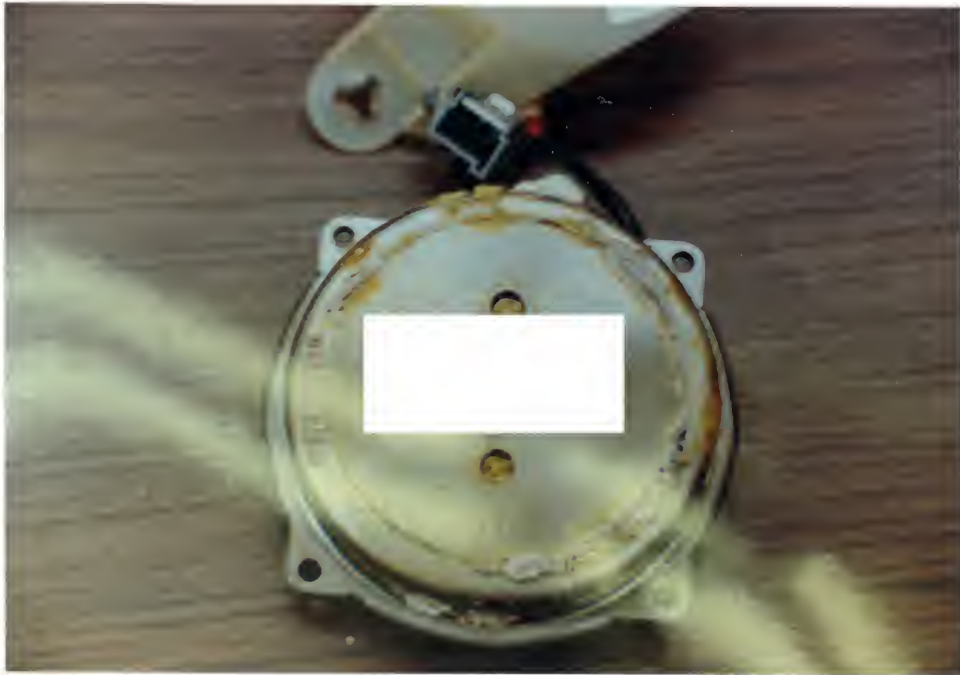
Air Bag Side Of The Inflation Module.

The air bag module assembly had been removed from the vehicle prior to our on-site inspection. The module was properly removed from the steering wheel without damage. The air bag was intact with no cuts or tears of the bag fabric. There was no evidence of driver contact on the bag (i.e., makeup transfers, etc.). Several faint stains which appeared to be blood were observed on the face of the bag.

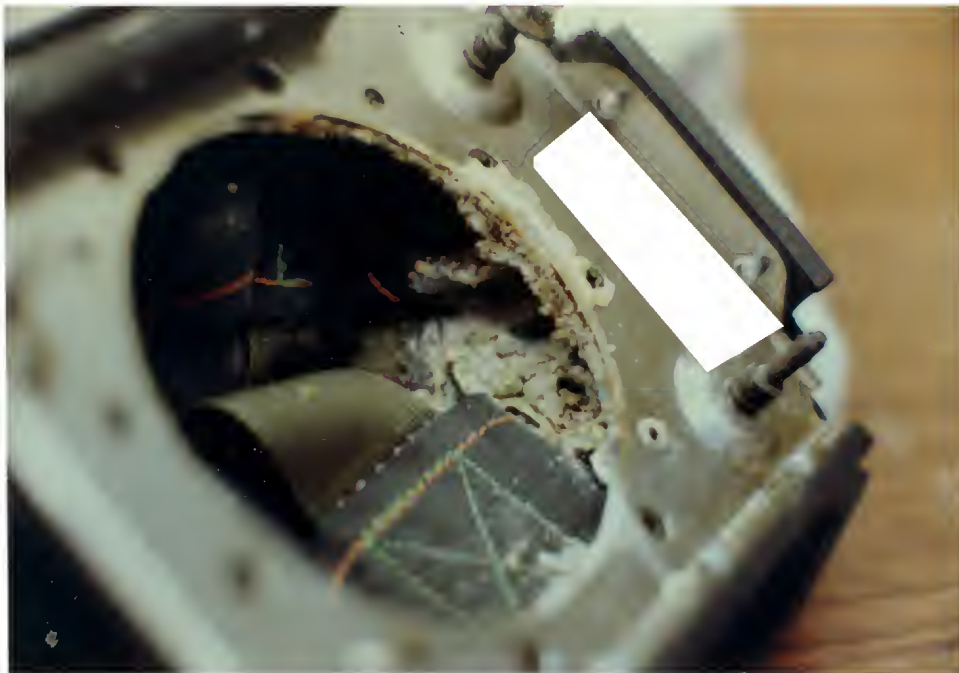
Generant Residue On The Inside Surface Of The Air Bag.

The air bag was of normal construction and measured approximately 23" in diameter in its deflated state. The bag was a tethered design and there was no damage to the internal tether straps or to the center reinforcement area of the bag. The air bag was vented by two ports located on the back side of the bag at the 10 and 4 o'clock positions. The air bag and module assembly were identified by the following numbers:

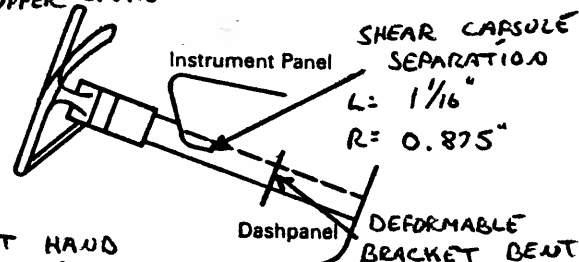
ABDOMINAL CONTACT TO STEERING WHEEL
RIM, WHEEL PROBABLY ROTATED 180° AT
TIME OF CONTACT
UPPER STEERING WHEEL DISPLACED

3.25" FORWARD, BENDING BEGINS 2" ABOVE
LOWER (L) SPOKE, CONTINUES CW TO (R)
UPPER SPOKE

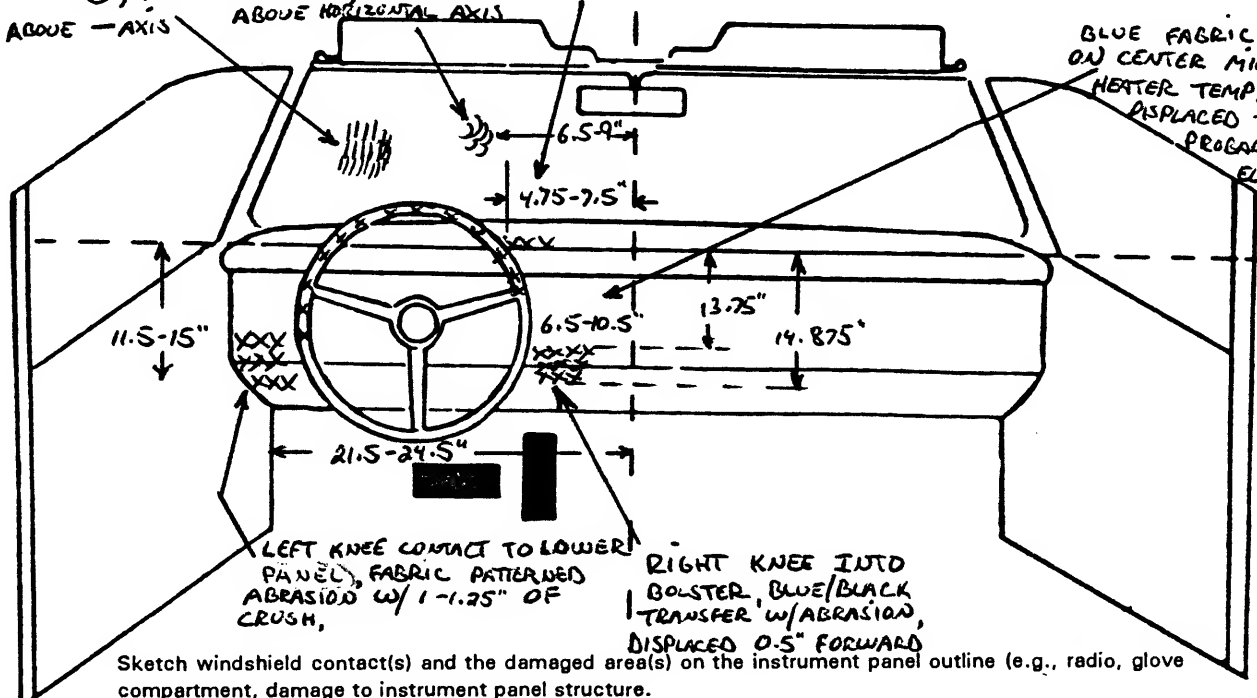
SHEAR CAPSULE
SEPARATIONL: 1 1/16"
R: 0.875"DASHpanel DEFORMABLE
BRACKET BENT
.75" AT UPPER
EDGE, .625" AT
LOWER EDGEVERTICALLY ORIENTATED
FABRIC (PROBABLE AIR
BAG) TRANSFERS TO
GLASS, 13-19" (L), 4.75-

9.25" ABOVE - AXISAPPARENT TISSUE
TRANSFER TO GLASS
OR SKIN ON CHUOGE
6.5-9" (L) 6.5-8.25"
ABOVE HORIZONTAL AXISPROBABLE RIGHT HAND
CONTACT TO UPPER PANEL,
1.625" LONGITUDINAL CRACK,
PADDING SLIGHTLY SEPARATED
FROM PLASTICBLUE FABRIC TRANSFER
ON CENTER MID PANEL
HEATER TEMP. CONTRL.
DISPLACED TO RIGHT,
PROBABLE (R)
ELBOW CONTACT
